TECHNICAL REPORT REMR-CO-3

CASE HISTORIES OF CORPS BREAKWATER
AND JETTY STRUCTURES

Report 6

NORTH PACIFIC DIVISION

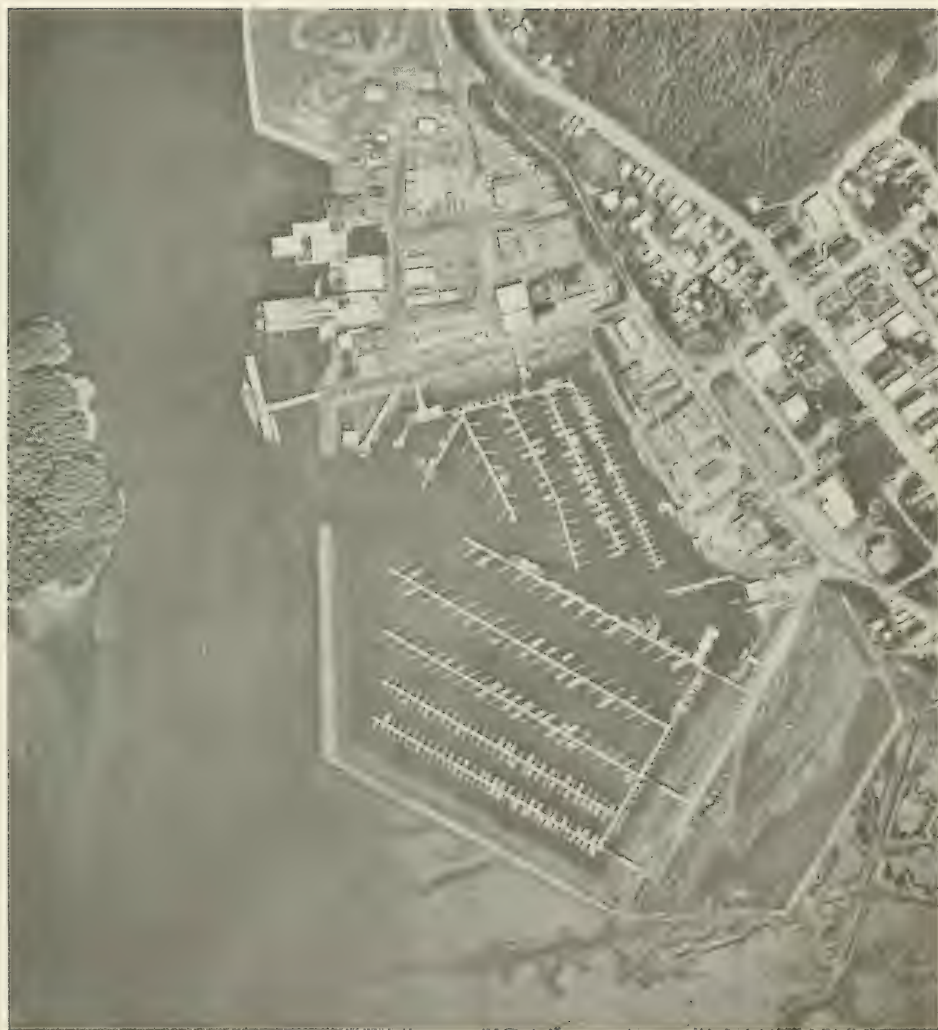
Figure 6. Aerial photograph of Cordova Harbor, Alaska, 1984

1985	The harbor is illustrated in Figure 5, and an aerial photograph of the harbor is presented in Figure 6. The breakwaters appear in good condition at this time.

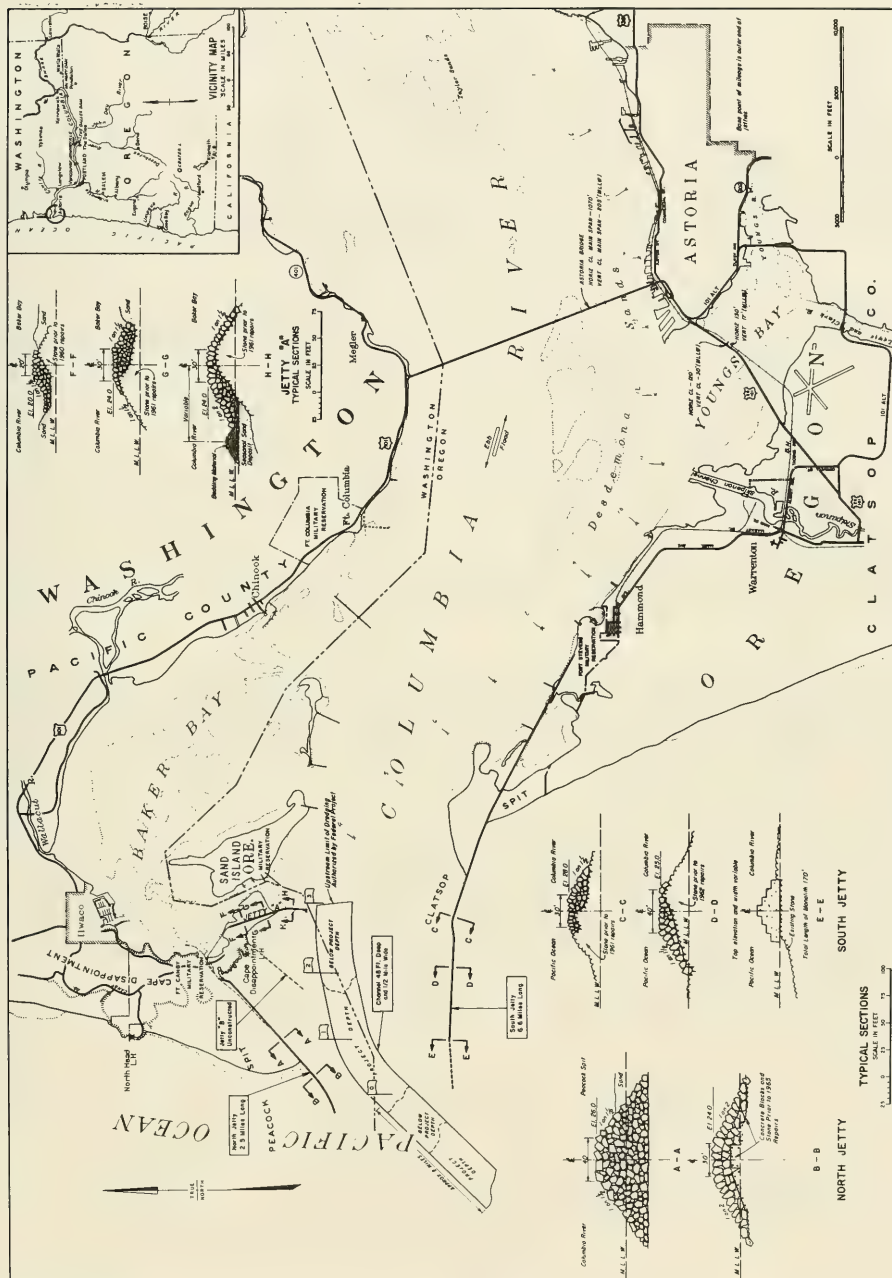
Figure 53. Site layout of Columbia River at Mouth, Oregon and Washington (revised 1979)

1964- 1965	The south jetty was repaired from "knuckle" to sta 158+00 with 308,101 tons of stone.
1965	The north jetty was rehabilitated with 136,935 tons of stone.
1982	The south jetty was repaired from sta 38+00 to sta 158+00 by filling of cavities in the structure.
1985	The harbor and cross sections of the jetties are illustrated in Figure 53. The north jetty and training jetty "A" have scour problems at the heads. The south jetty is in need of repair.

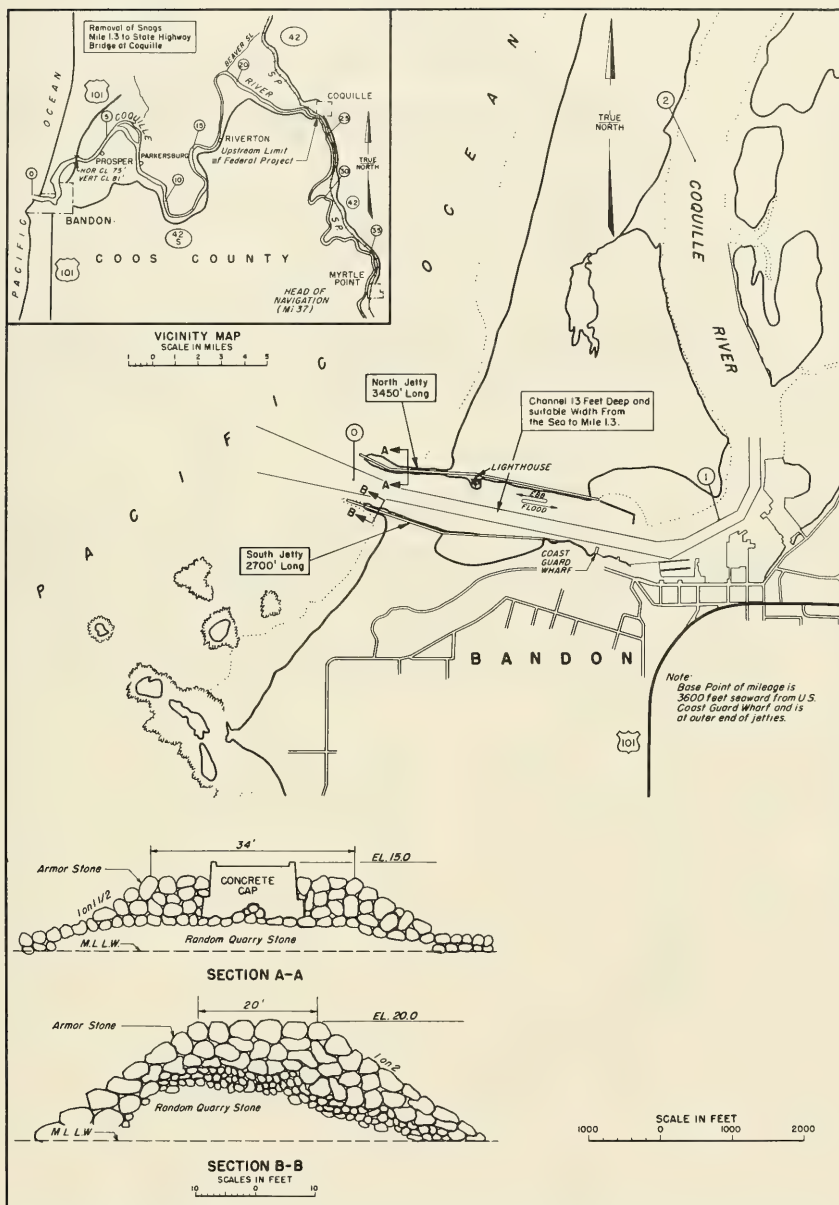
Figure 55. Site layout of Coquille River, Oregon (revised 1981)

1956	The north jetty was repaired, including placing concrete under the jetty cap in voids caused by erosion of the cap foundation stones and placing jetty stone along the north and south sides of the jetty cap. Stones were 50 percent class "A", weighing at least 4 tons and averaging 6 tons, and 50 percent class "B", weighing at least 1 ton and averaging 2 tons.
1982	The small-boat basin was constructed at Bandon, Oregon, including construction of a rubble-mound breakwater about 350 ft long with a crest elevation of +14 ft mllw and a crest width of 6 ft.
1985	The harbor and cross sections of the jetties are illustrated in Figure 55. The head of the north jetty is in need of repair, but it is still functional. The south jetty is in good condition.

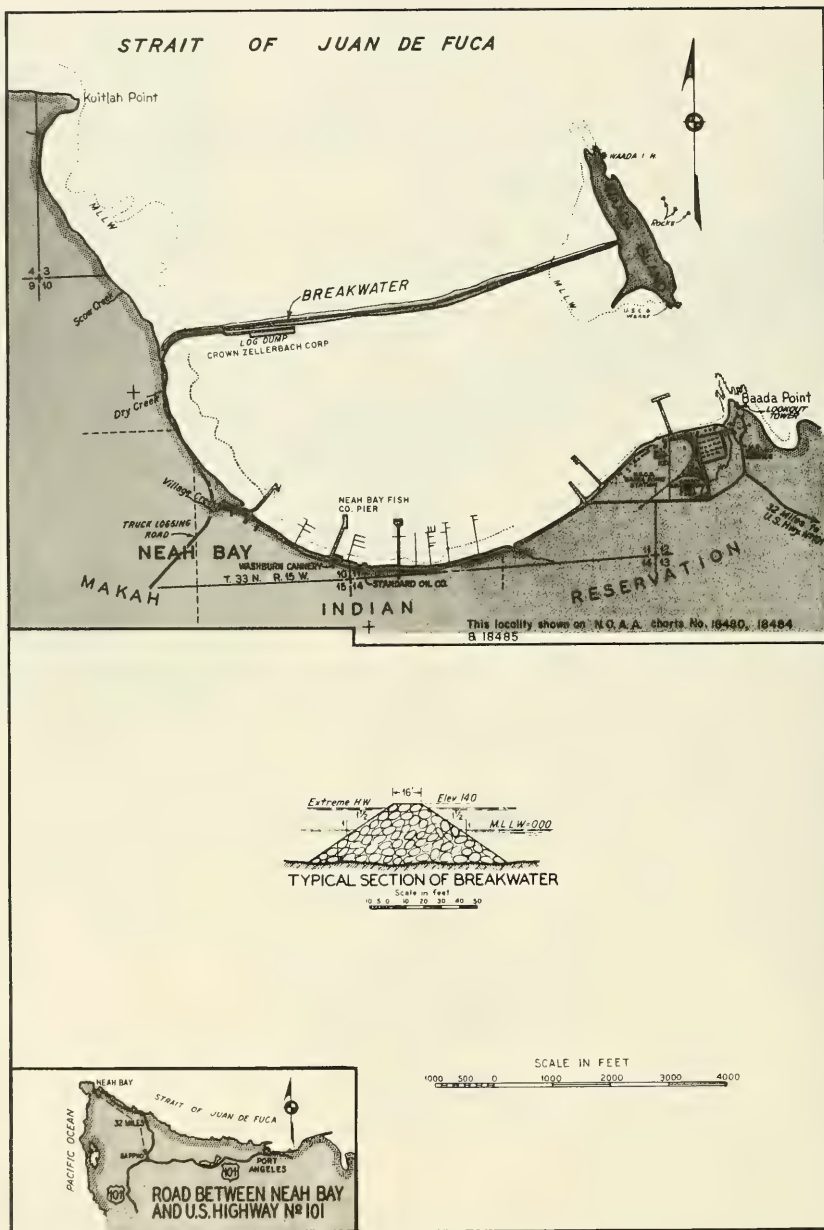
Figure 73. Site layout at Neah Bay, Washington (revised 1979)

1980	The westerly 4,200 ft of the breakwater was rehabilitated. The design specified a crest elevation of +18 ft mllw including a 5-ft-thick single layer armor rock protective cap. The crest width was 25 ft, and side slopes were 1:1.5.
1985	The harbor and cross section of the breakwater are illustrated in Figure 73. The breakwater appears in good condition at this time.
